## INVESTIGATIONS OF SHUTTLE MAIN LANDING GEAR DOOR ENVIRONMENTAL SEALS

Joshua Finkbeiner  
National Aeronautics and Space Administration  
Glenn Research Center  
Cleveland, Ohio

2005 Seal Workshop

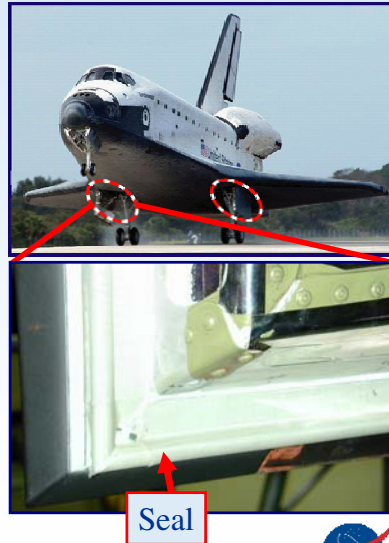
MLG door seals comprised of thermal barrier and environmental seal. This study focuses on the environmental seal for the MLG door. Photograph shows the installed environmental seal on the MLG door. Tape behind seal is removed before door closure.

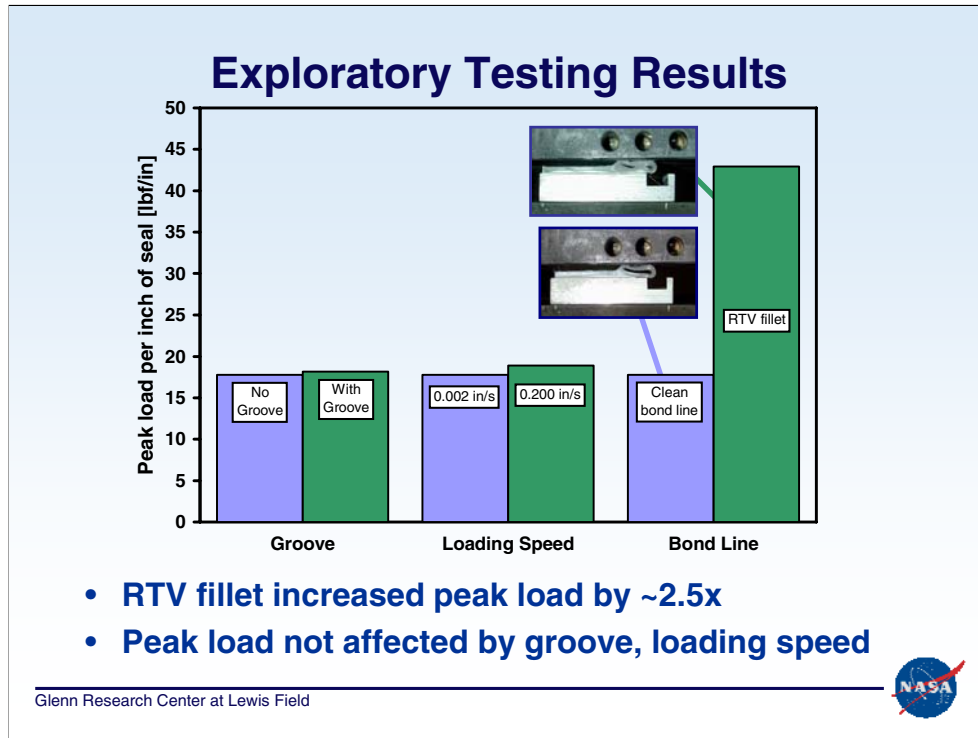
Compression results for exploratory tests with only the first cycles of each test shown. The graph is % compression vs. load generated in the seal, and the arrows indicate the different paths for loading and unloading portions of the testing cycle. The first five tests show results which are nearly identical, demonstrating that the presence of the adjacent groove and the seal loading speed do not affect the test results. The sixth test (blue curve) demonstrates that the presence of the RTV fillet increases the load by as much as a factor of three.

GRC recommended to JSC/KSC that removal of excess RTV from under the seal bulb would reduce generated loads and possibly allow MLG door closure. The seal installation procedures were amended to include the removal of excess RTV.

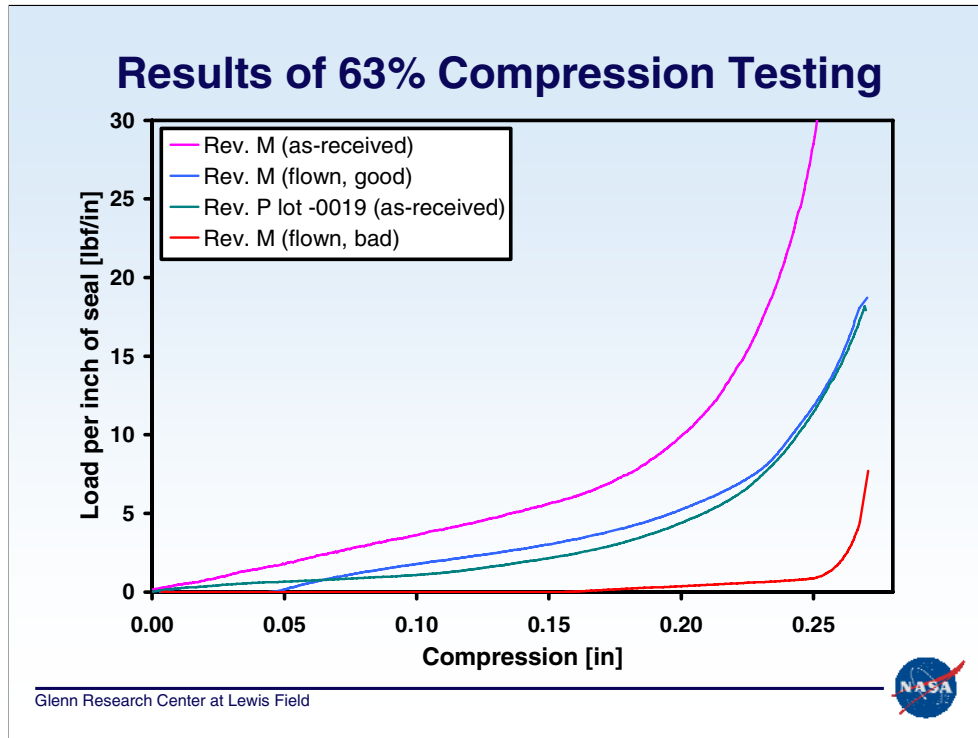
Chart shows results from four seals (two as-received, two flown) for systematic compression tests. The graph is compression distance [in] vs. generated load per inch of seal. The as-received Rev. M data is plotted twice: once in its as-measured state, and once shifted to the right (i.e. higher compression) by 0.035 in.

The as-received Rev. M specimen demonstrated the highest loads of the specimens tested, and the “bad” flown Rev. M demonstrated the lowest. With approximately 0.160 in. of permanent set, the “bad” flown specimen did not generate load until the upper platen contacted the bulb.

The as-received Rev. P data falls far below the as-received Rev. M specimen and is even lower than the “good” flown seal data. The reduction in generated load may be due to the lack of Nomex impregnation of the seal bulb. The as-received Rev. M seal generated five times the load of the as-received Rev. P seal for 63% compression.

**What does this mean?** Rev. P seals may be used as replacements for Rev. M seals without danger of overloading Shuttle structures. As-received Rev. P seals can be expected to generate lower loads (as much as five times) than as-received Rev. M seals. Permanent deformation in the seal bulb reduces the load generated by the seal.

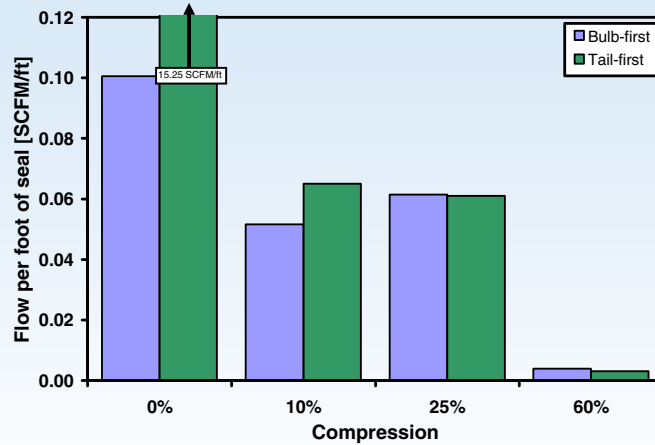
## Flow Test Results (Rev. P Seal)

- Bulb-first (descent) flow rates below 3 SCFM/ft leakage limit
- Tail-first (ascent) flow rates much higher at low compressions
- Effect of orientation disappears by 25% compression

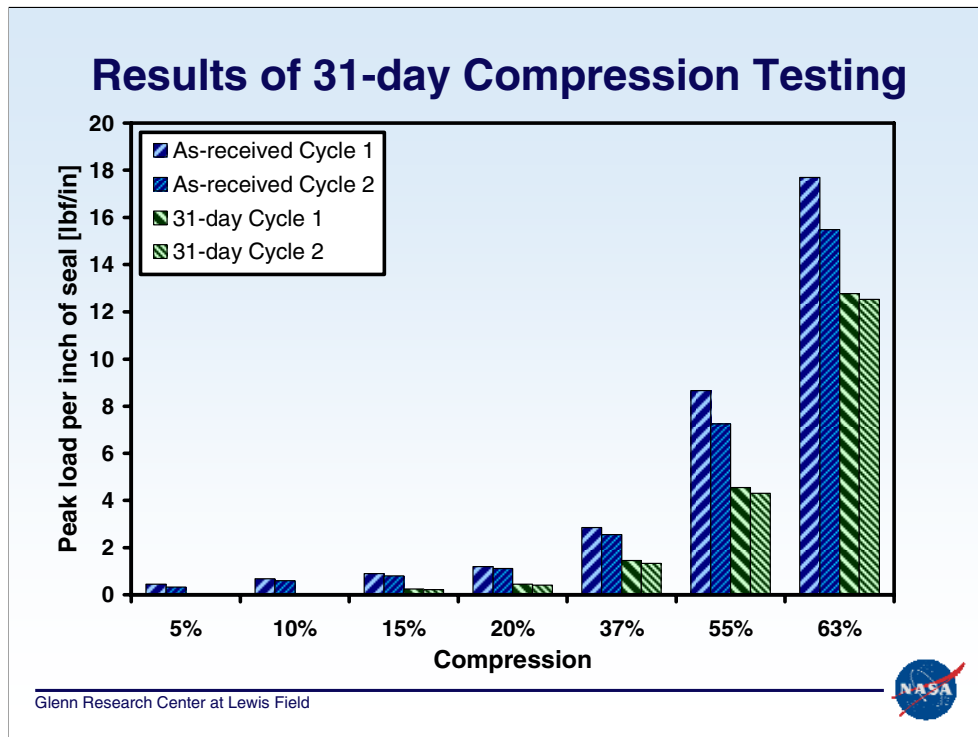
This graph shows the peak load per inch of seal vs. discrete compression levels applied to the seals for each of the two loading cycles. Both seal previously held at 63% compression for 31 days and an as-received control specimen are shown. The as-received specimen was measured to have 0.050 in. (12%) permanent deformation after release from the 31-day compression fixture.

The control specimen generated small amounts of loads immediately, while the 31-day compressed specimen did not generate any measurable load until 15% compression. Since the 31-day specimen was found to have 12% permanent deformation after the compression, the upper platen of the fixture did not contact the seal for 5% and 10% compression and generated no load for these displacements. Meanwhile, at 63% compression, the first cycle of the post-compression specimen generated 80% of the load of the as-received specimen.

Of particular interest was the drop-off in load of the as-received specimen between the first and second loading cycles and the relatively small load reduction in the compression specimen. If load drop-off is assumed to be proportional to permanent deformation, the data indicates that a seal with permanent deformation takes on new deformation more slowly than a pristine seal.

**What does this mean?** Seals held at compression for 31 days will take on some permanent deformation (0.050 in. in this test). However, the rate at which the seals take on permanent deformation appears to decrease as the seal takes on more deformation.
